On 8th February, 1956 D.T.S.D. held a meeting to discuss details of the trial requirements for H.M.S. DIANA in Operation MOSAIC. Minutes of this meeting were circulated under T.S.D. 4046/56 dated 15th February, 1956 - copy enclosed.

Recommendations Concerning the Stationing of  
H.M.S. DIANA and the Scientific Whaler

H.M.S. DIANA'S REPORT ON CRYPTIC MOSAIC

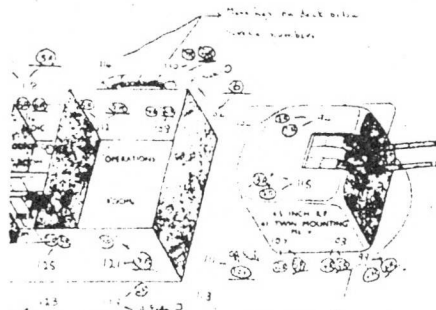
Watertight Sub-division and Access

Decks 02, 01, 1 and 2

01 DECK

ITEMS SHOWN IN - - - LINE ARE WATERTIGHT  
BULKHEADS SHOWN IN - - - - - LINE ARE NON-WATERTIGHT  
BLUE SERIAL NUMBERS ARE NOT MARKINGS

NO. 1 DECK

NO. 2 DECK

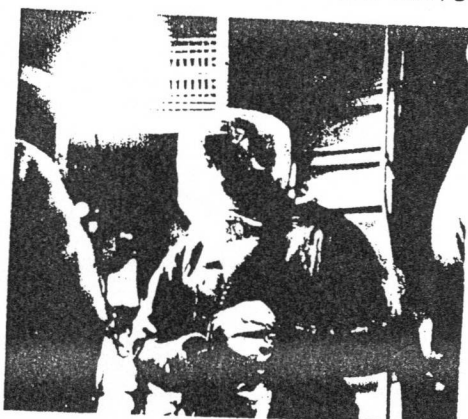
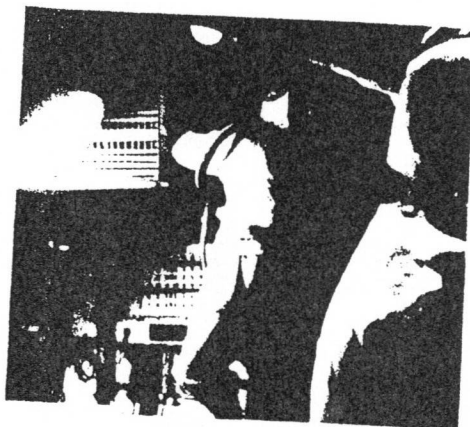
FIG. 1

ENTERING SPACE, USING HAND-BELLOWS FOR AIR SUPPLY.

COMPLETE ENGINE-ROOM WATCH

- d) As the machinery space ventilation was closed down, the watchkeepers in 'A' Engine Room and 'B' Boiler Room were relieved by a skeleton watch wearing experimental air-ventilated suits for protection against temperature conditions. 'A' Boiler Room and 'B' Engine Room were evacuated, and all access hatches closed. Some photographs of the air-ventilated suits in use are shown in Fig.1.
